DOT/FAA/CT-94/53

# Joint Sealants for Airport Pavements

April 1995

Final Report

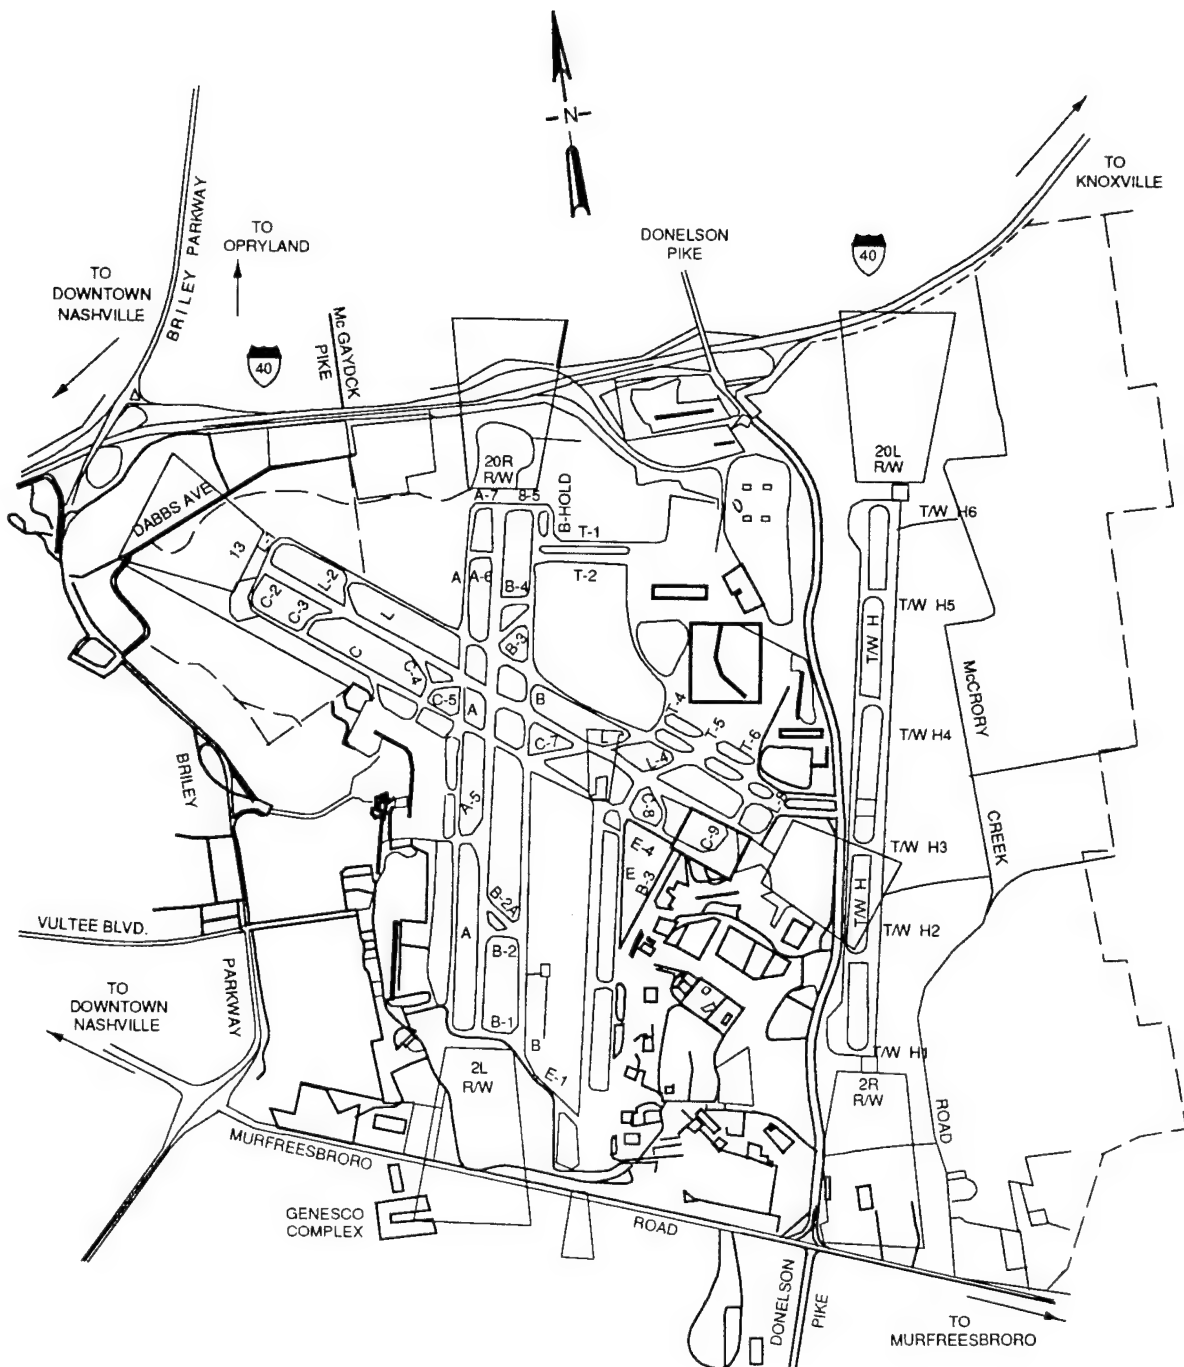
Figure 1. Site Map of Metro Nashville Airport.

To eliminate as many variables as possible, the purchased sealants were stored in a temperature controlled area at WES until they were required in the field, the same batch or lot number of each of the selected sealants was used at all five locations, and the joint configuration at all locations were as similar as possible. Each project site consisted of approximately 10,000 linear feet of sealed joints. Approximately 5,000 linear feet of those joints were located in a taxiway area and 5,000 linear feet were located in a parking apron or gate area. For example, the two small highlighted blocks in figure 1 illustrate the locations of the joint sealant sections at the Metro Nashville Airport, one of

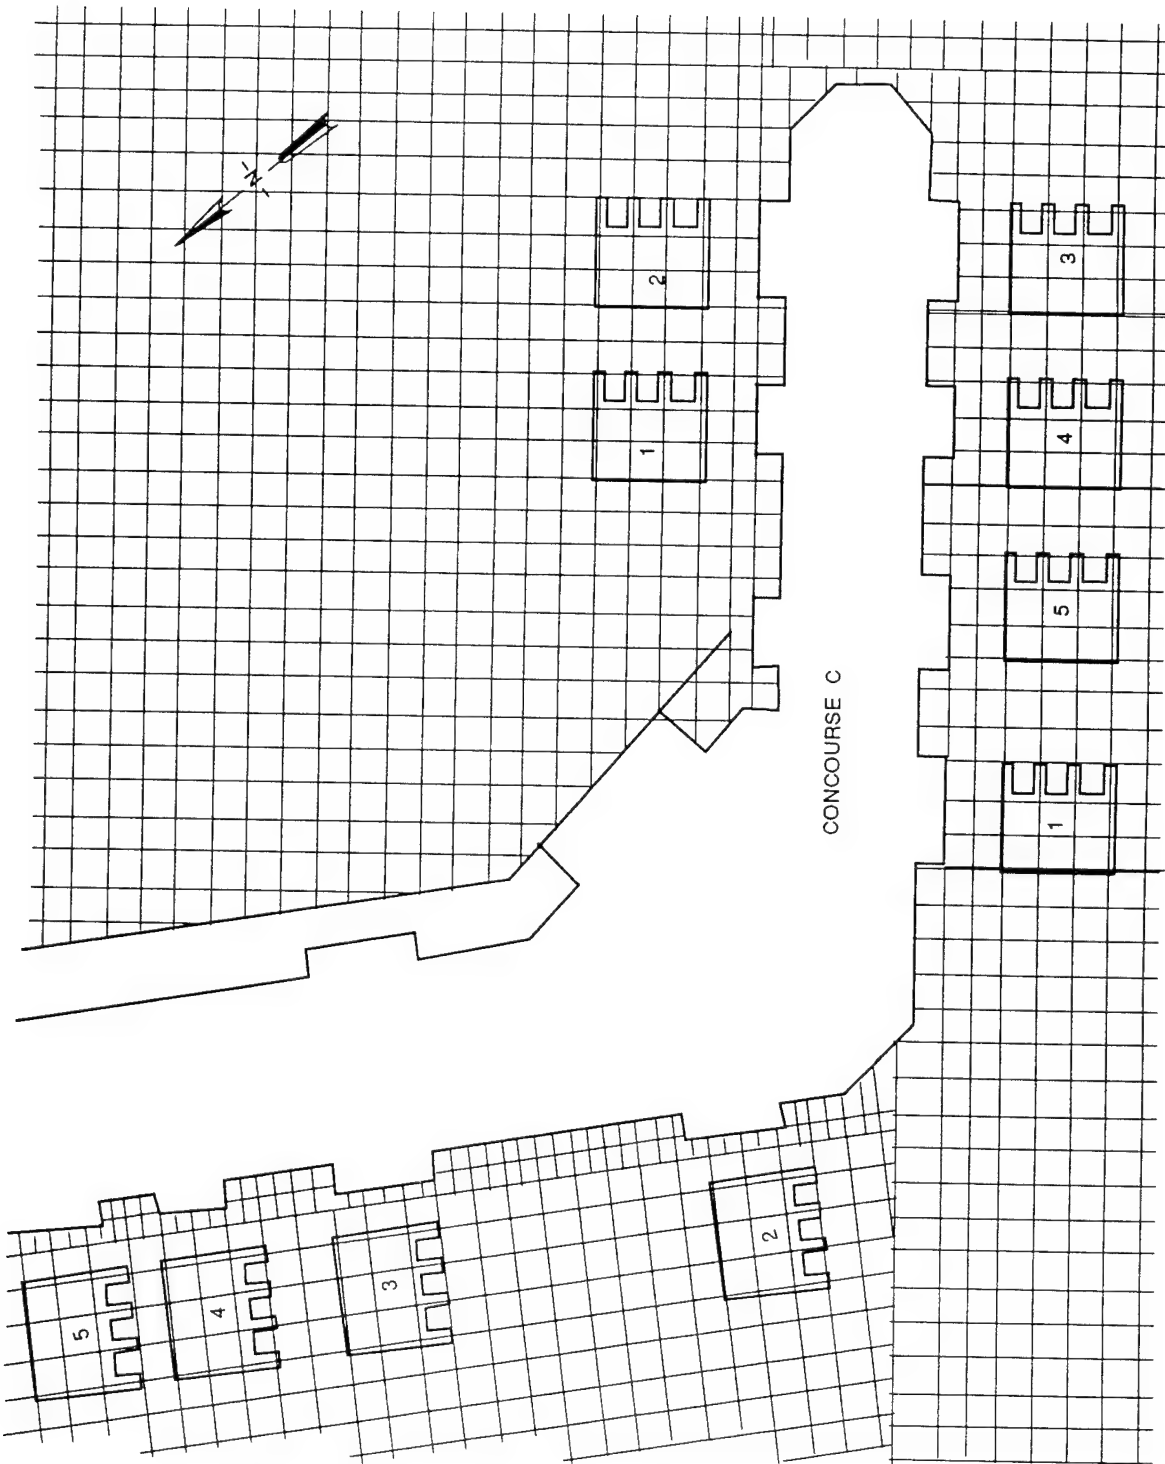
Figure 2. Concourse C at the Metro Nashville Airport  
(numbered blocks indicate areas sealed)

the selected airports. Concourse C was selected as the area where the joints would likely receive fuel spillage and Taxiway C-9 at the end of Runway 31 R/W was selected for the non fuel spillage area. Figure 2 provides a close up view of the pavement around Concourse C that was sealed during the project. Figure 3 provides a close up view of Taxiway C-9. These figures illustrate the typical pattern used for each section and the numbers used in Figures 2 and 3 represent the sealant that was installed in that area. The sealant location at each of the five airports was selected so that the materials would be exposed to the same type of traffic and environmental conditions at the particular airport. The joint sealant locations at the other airports are provided in appendix A.

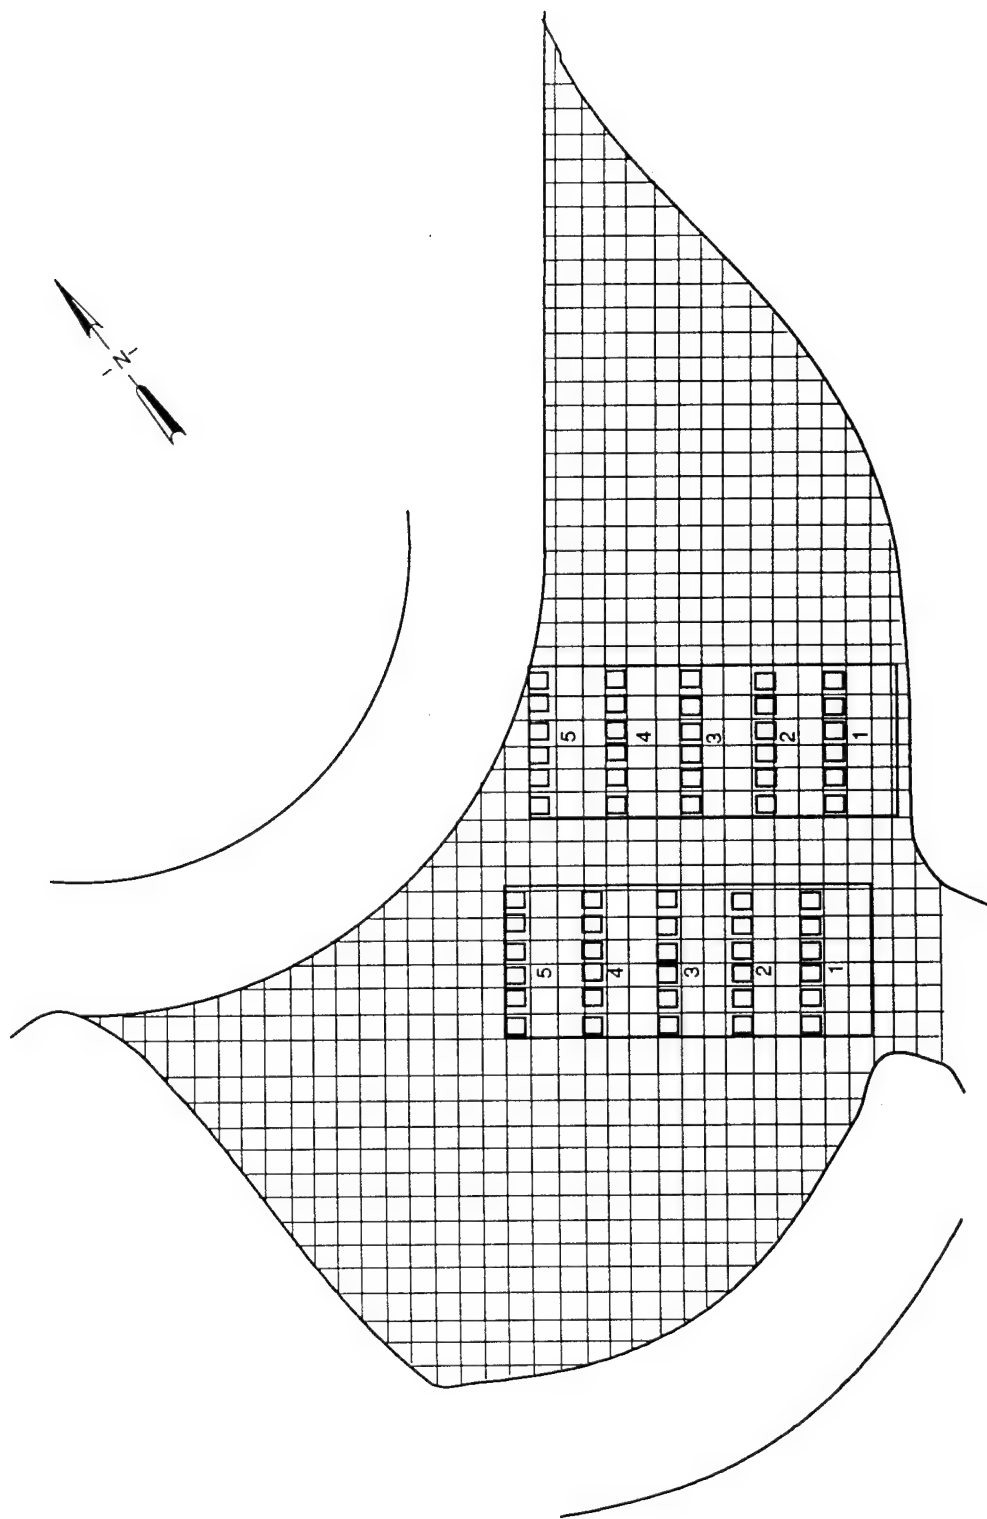
Figure 3. Area C-9 at the Metro Nashville Airport.

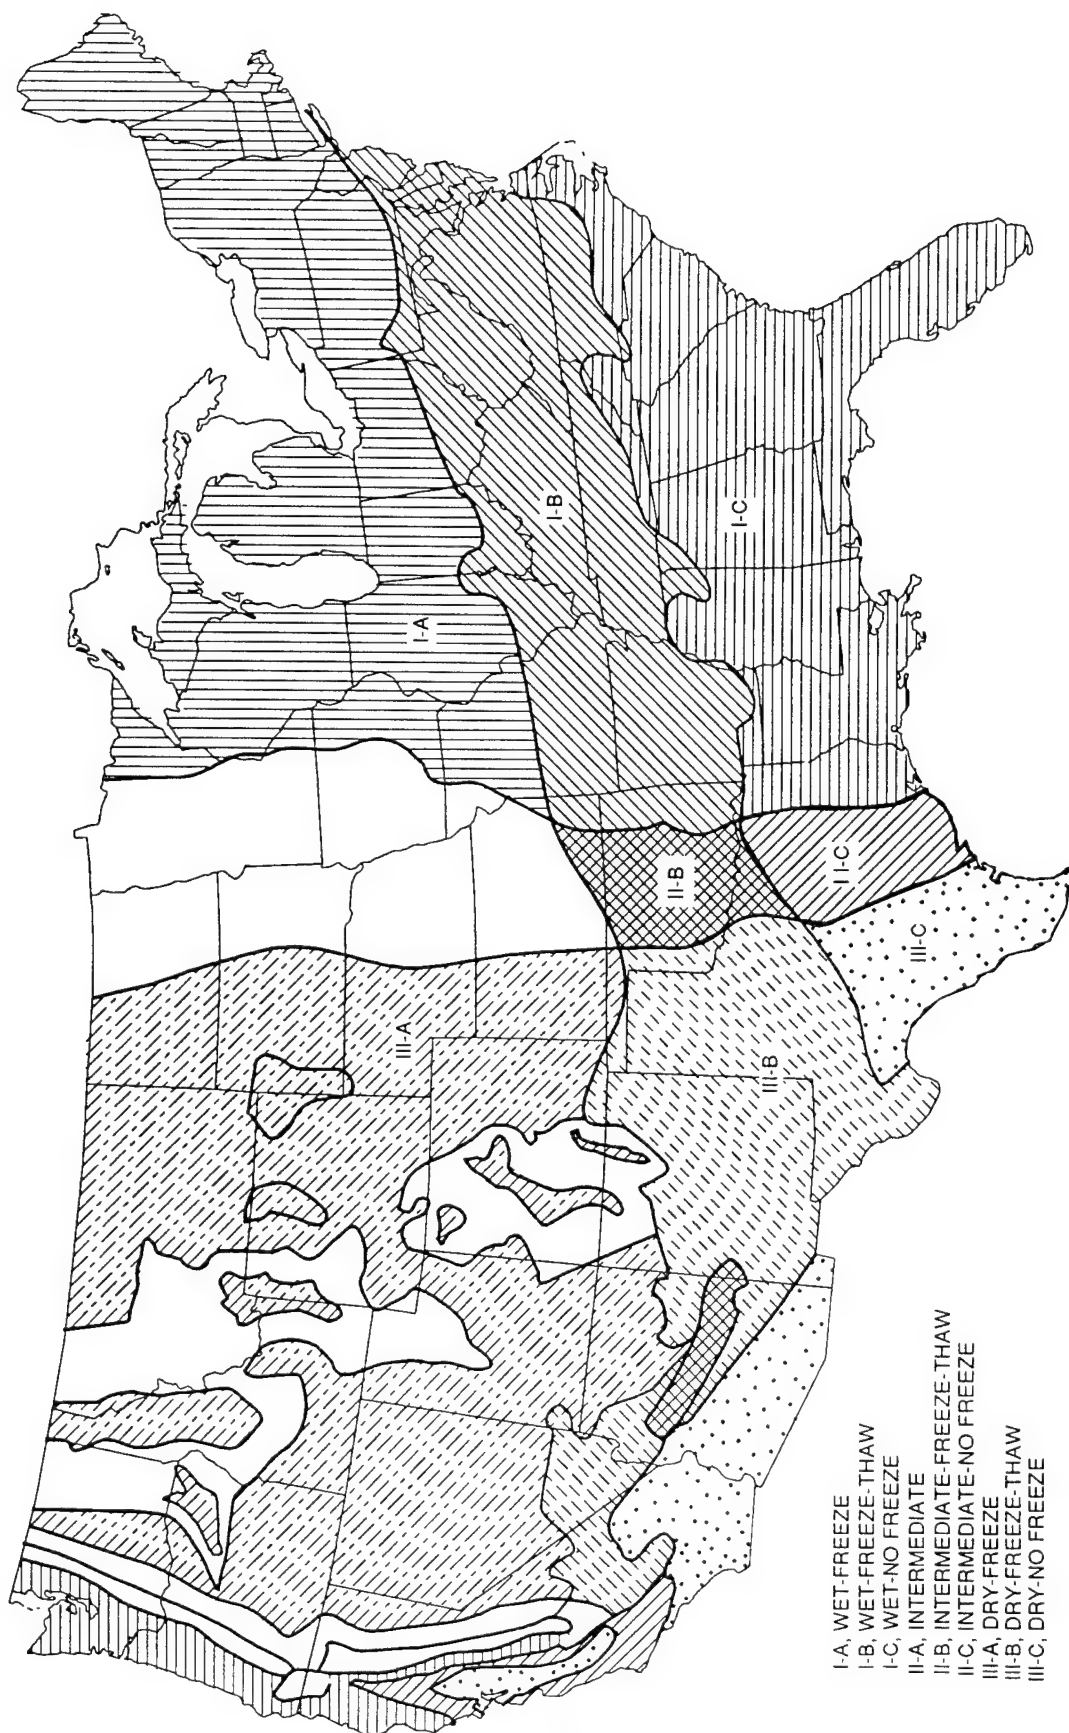
Figure 4. Climatic Regions of the United States  
 Taken from page 23 of NCHRP-SHP 98 (Peterson, 1982).

Figure 4 taken from Peterson (Peterson 1982), was used to define the climatic regions and to ensure that the airports selected were in different climatic regions. The climatic regions which were selected are not necessarily the most severe, but they are the ones which cover 80 to 90 percent of the United States. Therefore, the sealant performance in these climatic regions may be more representative to other areas in the United States.

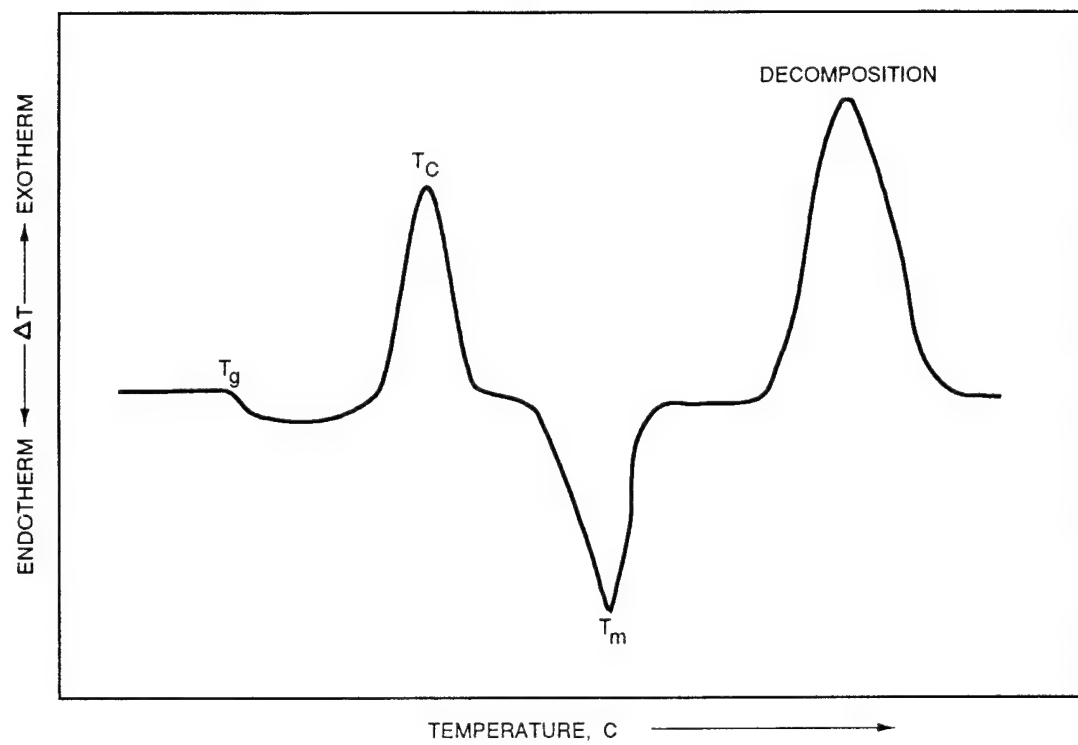
Figure 5. Typical DSC Analysis Results.

For example, figure 5 illustrates typical results that can be obtained from DSC analysis. Four regions are evident in this figure. The first region is the glass transition temperature ( $T_g$ ) which is an endothermic process. Below  $T_g$ , the polymeric material undergoes a significant change in properties due to the virtual cessation of local molecular movement. In the case of a pavement joint sealant, the properties would change from being soft, flexible, and resilient above the  $T_g$  to hard, stiff, and brittle below  $T_g$ . Theoretically, this implies that when the joint begins to open during cooler temperatures, the sealant could fracture and fail. Based upon this discussion, it would appear that the user would simply select a sealant that has a  $T_g$  below the minimum expected temperature to which the sealant would be exposed. However, the  $T_g$  of various materials can be increased by the aging and weathering of the material. The  $T_g$  can also be increased if the material continues to cure or if additional cross-linking occurs. The increase in  $T_g$  could be significant enough to make the sealant become brittle at normal temperatures experienced during the winter months.

Often the  $T_g$  of polymeric materials is not as easily discernable as illustrated in figure 5, especially if the material is a mixture of constituents. Also some of the raw materials used to produce joint sealant materials, asphalt cement and coal tar for example, do not exhibit a true well-defined  $T_g$ .

The second region marked on the figure is the temperature at which crystallization ( $T_c$ ) occurs in the material and it is an exothermic process. This peak will be present only in materials that exhibit some crystallinity (i.e., an ordering of the molecules or a preferred orientation of molecules that is repeated throughout the system). It was expected that most of the pavement joint sealant materials would be amorphous in nature (i.e., no

The last region on the thermogram in figure 5 is decomposition. This is the temperature at which the material begins to char and burn. The other regions that have been discussed are reversible, that is if the temperature is decreased below the  $T_m$  the material will revert back to a solid. If the temperature is decreased below the  $T_g$  the material becomes brittle, etc. However, if the material is exposed to temperatures above the decomposition temperature and then the temperature is reduced, the material does not regenerate.

One other region that may be exhibited by some materials is an exothermic peak indicating cross-linking in the material. On figure 5, this region would be present between the  $T_m$  and the decomposition temperature. Some of the coal tar-based materials used in this investigation undergo some cross-linking. It is expected that most of the cross-linking occurs during the heating and application of the material and therefore would not be evident

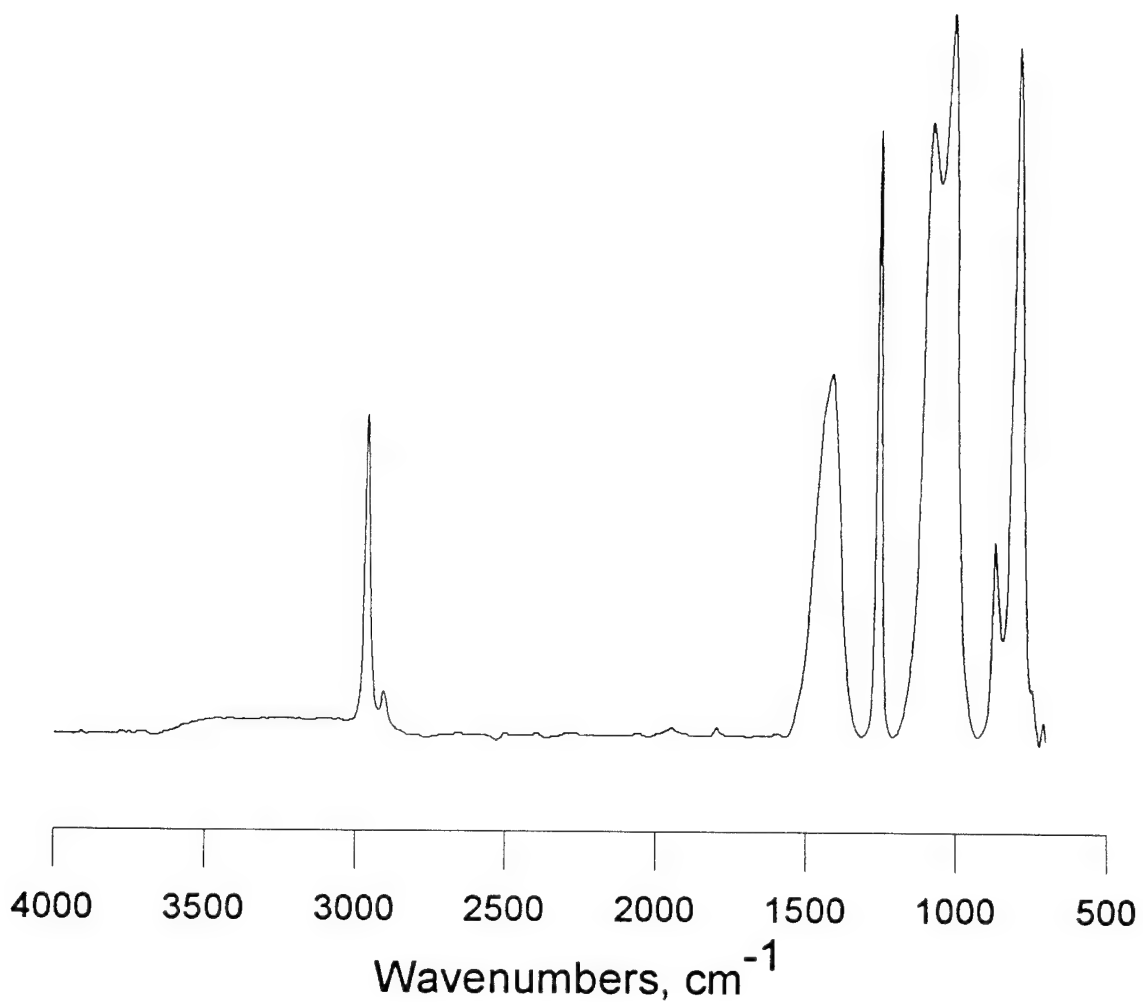
Figure 6. Example of a Fourier Transform Infrared Spectrum.

FTIR is based upon the principle that most organic compounds absorb energy in the infrared region. When an infrared beam of radiation is passed through a sample, the covalent bonds of the different functional groups absorb energy at specific characteristic frequencies. A plot of the amount of energy absorbed by a sample versus frequency is called a spectrum. An example of a spectrum is shown in figure 6. The peaks evident in the spectrum indicate specific chemical functional groups.

The sample and IRE were then placed into the FTIR sample compartment where an infrared beam of energy was passed through the IRE. The IRE causes the beam to undergo multiple internal reflections which creates an effect called the evanescent wave. The beam is then collected by the detector and is converted to the type of spectra shown in figure 6.

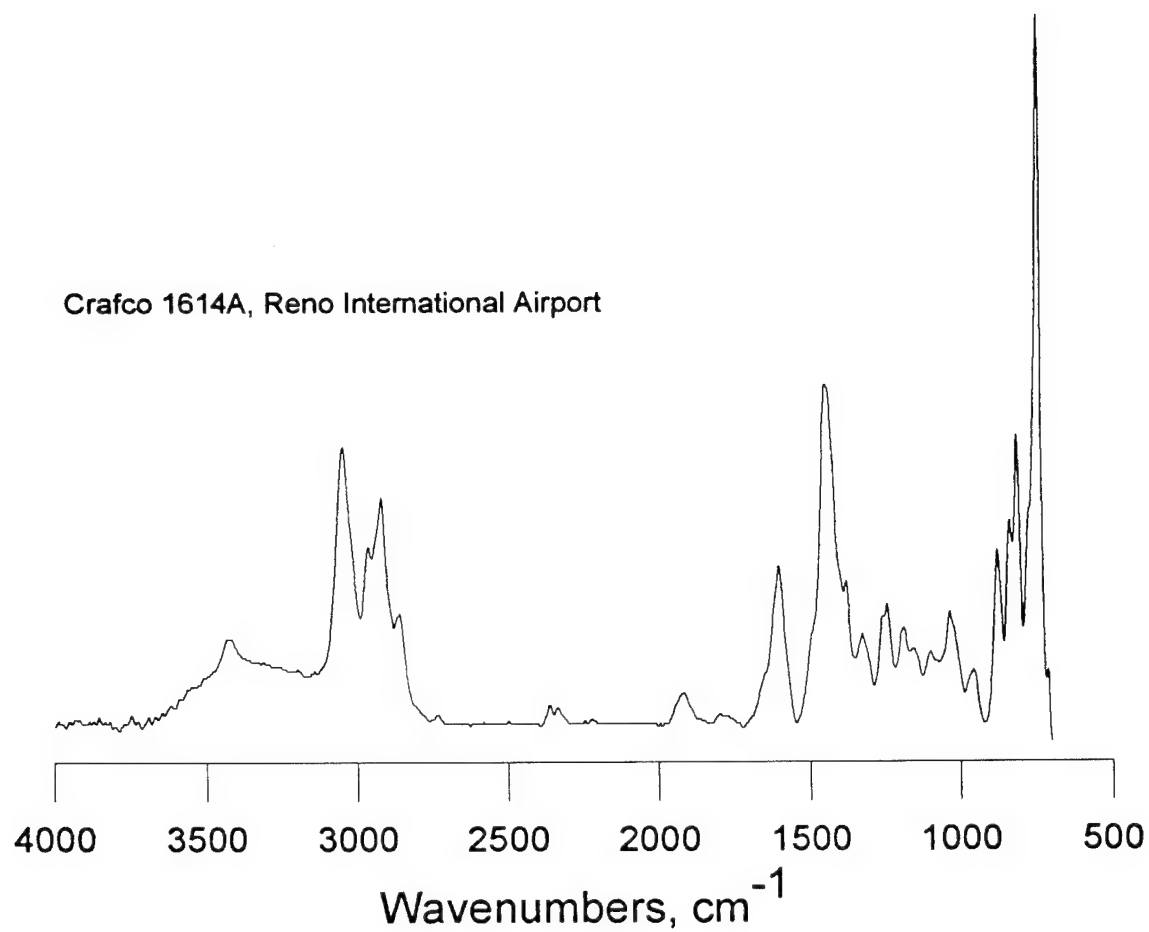
Figure 7. FTIR-ATR Spectra of Crafco Superseal 1614A.

In figure 7, the FTIR-ATR spectrum of the Crafco Superseal 1614A material sampled from the North Ramp at Reno International Airport is shown. The MSDS available for the 1614A material lists coal tar and rubber as major components of this joint sealant. The aromatic nature of the coal tar material is evident by the peaks near  $3000\text{ cm}^{-1}$  (aromatic C-H stretch)  $1960\text{ cm}^{-1}$  (overtone or combination bands), and the bands from  $1600\text{--}1400\text{ cm}^{-1}$  (aromatic C-C stretch). The peaks centered around  $1025\text{ cm}^{-1}$  arise from the in-plane bending of aliphatic hydrogens and the peaks near  $750\text{ cm}^{-1}$  from the out-of-plane bending. There is a broad band centered at  $3400\text{ cm}^{-1}$  indicative of intermolecular hydrogen bonding of alcohols and phenols. Due to the heterogenous nature of coal tar materials, it is impossible to assign specific peaks to either the coal tar or the rubber. This spectrum is representative of the additional samples collected from the other test areas in which this sealant was applied. Although not shown, additional spectra were obtained at approximately 6-month intervals over the course of 1 to 1.5 years after the sealants were placed into service. Examination of these spectra yielded no evidence of observable chemical changes occurring in the 1614A material with 1.5 years of aging. As with other bituminous materials, reaction with atmospheric oxygen over time results in the formation of carbonyl-containing compounds, with the appearance of bands near  $1750\text{ cm}^{-1}$ .

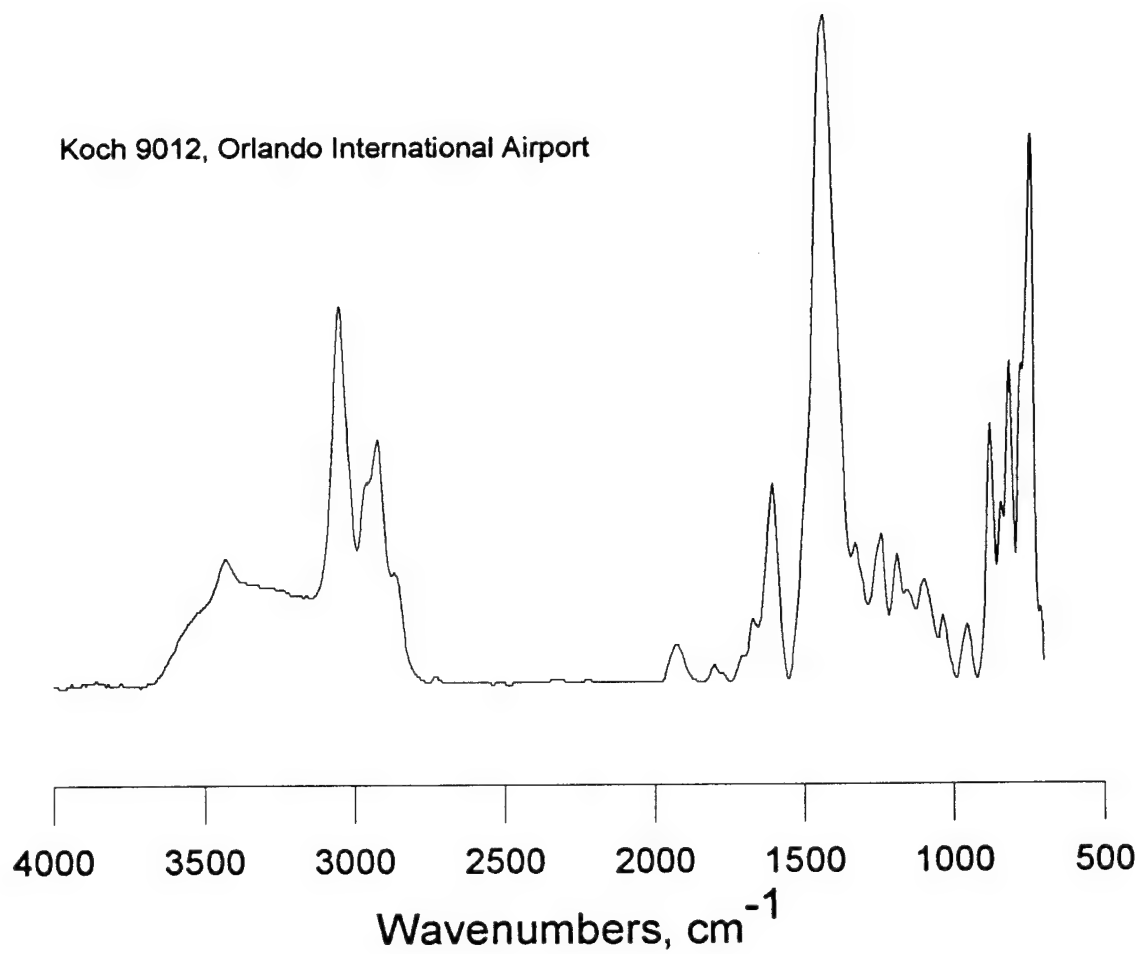
Figure 8. FTIR-ATR Spectra of Koch Materials Product 9012.

The FTIR-ATR spectrum of the Koch 9012 joint sealant material is displayed in figure 8. The MSDS of this material, as with the Crafco 1614A product, lists coal tar as a major ingredient. Again, this is supported by the FTIR data which shows strong aromatic peaks at  $3000$ ,  $1960$ , and  $1600\text{ cm}^{-1}$  with aliphatic peaks near  $2900\text{ cm}^{-1}$ . The peaks near  $1025\text{ cm}^{-1}$  arise from the in-plane bending of aliphatic hydrogens and the peaks near  $750\text{ cm}^{-1}$  from the out-of-plane bending. This material is similar to 1614A in that no observable chemical changes are noted from the FTIR spectra collected over a period of months.

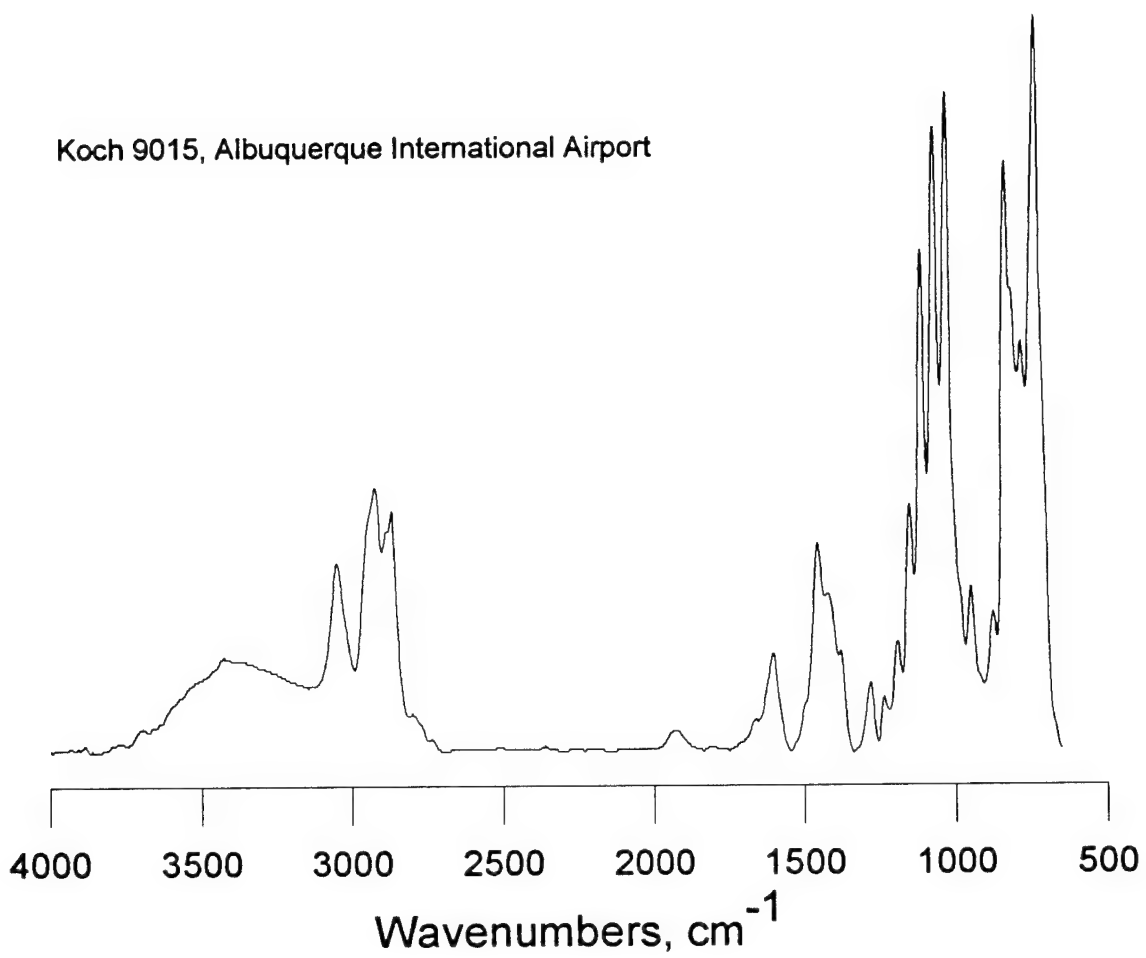
Koch 9015, Albuquerque International Airport

Figure 9. FTIR-ATR Spectra of Koch Materials Product 9015M.

In figure 9, the FTIR-ATR spectrum of the Koch 9015M product is shown. From the MSDS, and discussions with company representatives, this material reportedly contains a mixture of coal tars and oils and polysulfide polymer. Examination of the FTIR spectrum and comparison with the previous spectrum of the coal tar materials reveals aromatic peaks above  $3000\text{ cm}^{-1}$ , near  $1600$ , and  $1450\text{ cm}^{-1}$  with aliphatic peaks near  $2900$ ,  $1025$ , and  $750\text{ cm}^{-1}$ . However, there are several other peaks that probably arise from the presence of the polymer material in the region from  $1250\text{--}1000\text{ cm}^{-1}$ . These peaks are found in the range that sulfide (C-S-C) and related ether (C-O-C) linkages absorb. Analysis of the spectra collected over the course of this study indicate no readily observable chemical changes as viewed by FTIR-ATR.

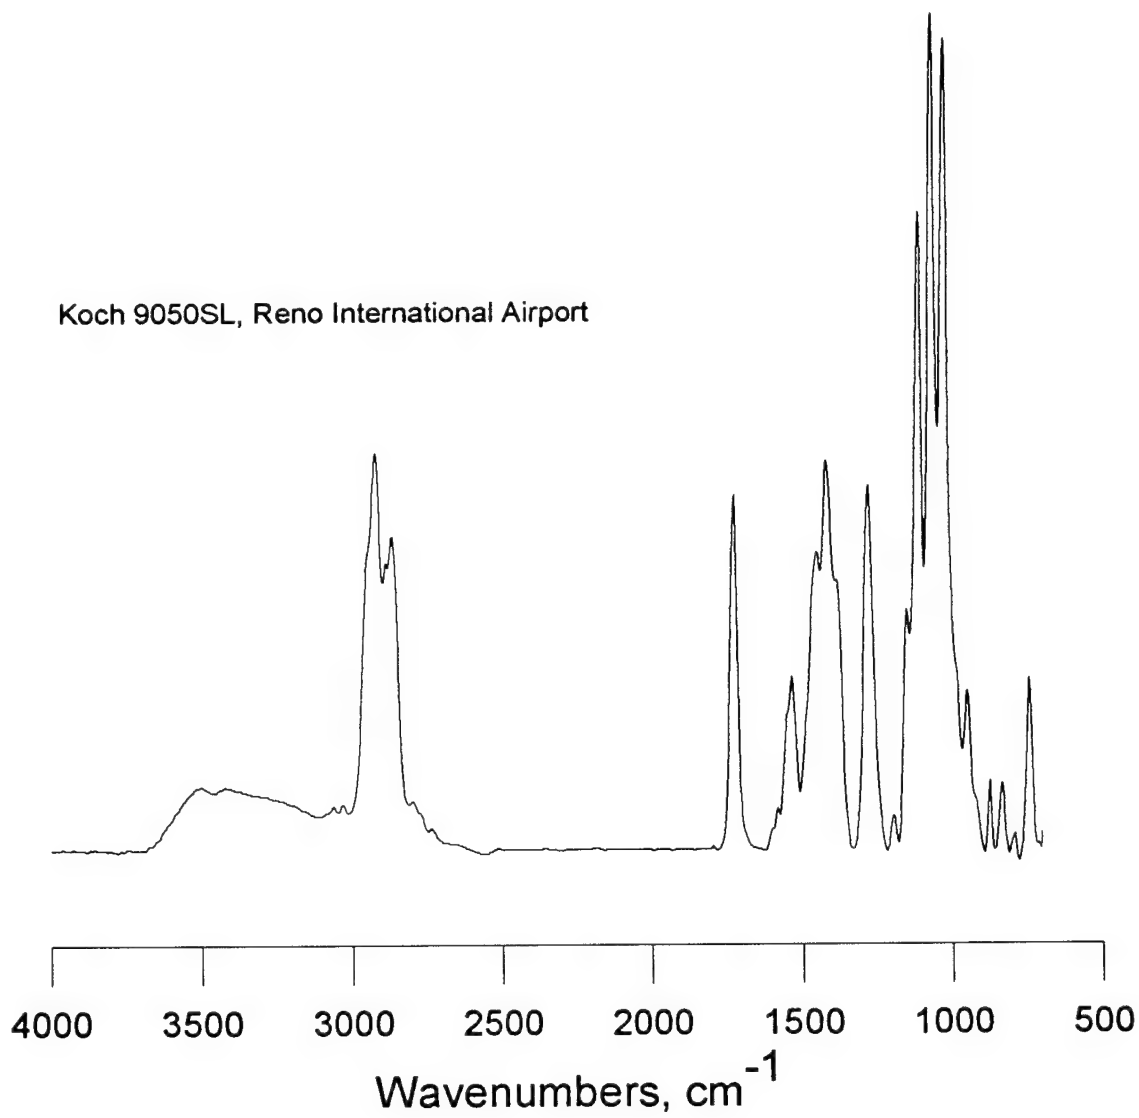
Figure 10. FTIR-ATR Spectra of Koch Materials Product 9050SL.

Representative FTIR-ATR spectra for each of the sealants analyzed in this study are presented in figures 7 - 11. The spectra are those of actual samples collected from the field.

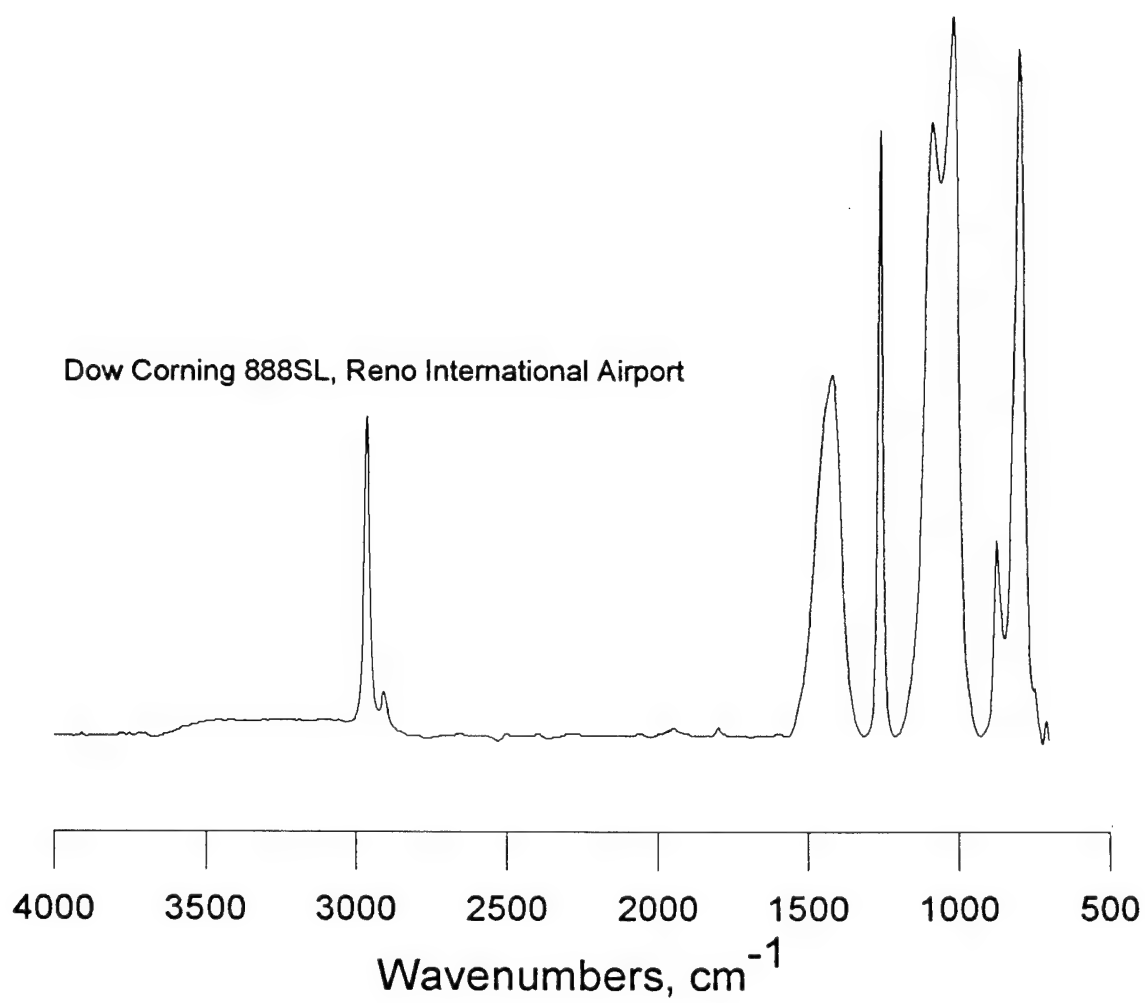
Figure 11. FTIR-ATR Spectra of Dow Corning® 888SL.

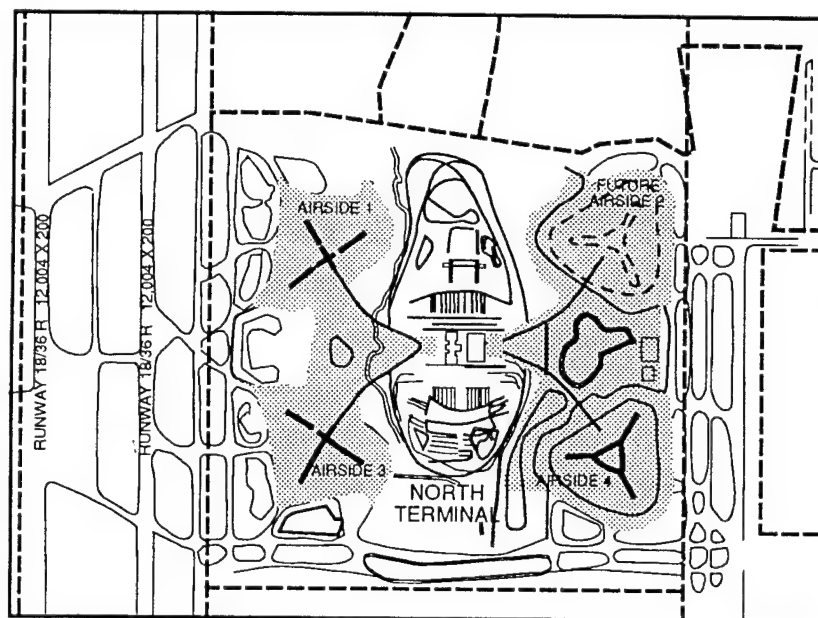
Figure A-1. Area Sealed at Orlando International Airport.

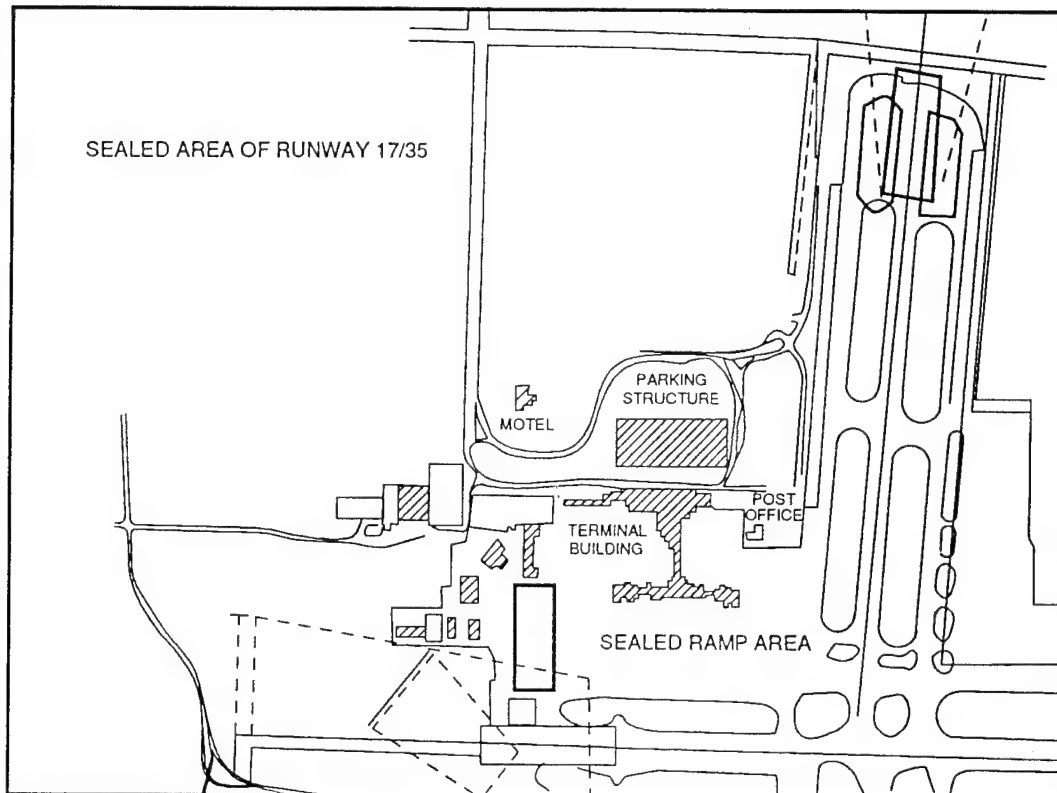
Figure A-2. Area Sealed at Albuquerque International Airport.

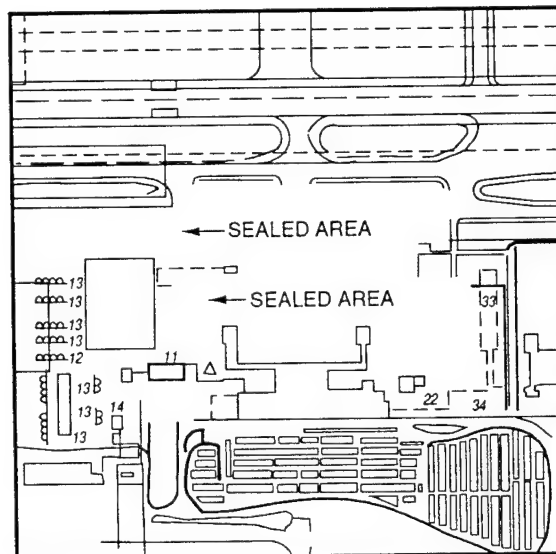
Figure A-4. Area Sealed at Reno-Cannon International Airport.

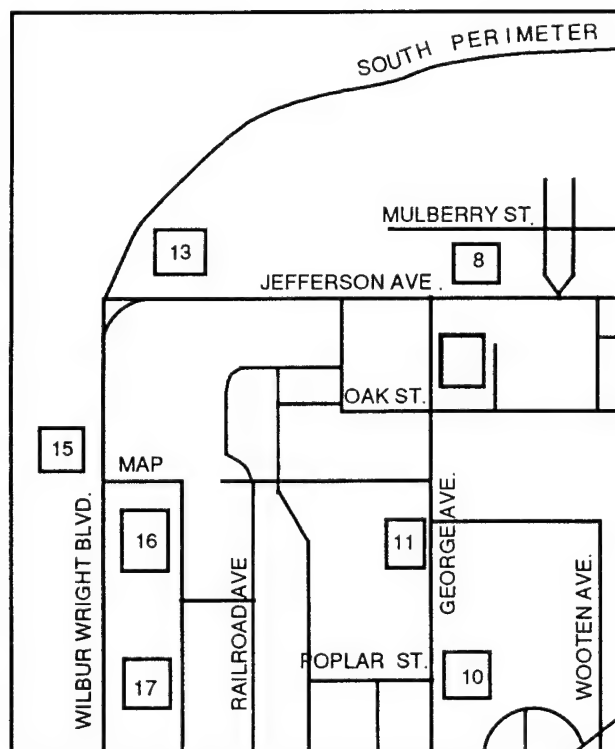
Figure A-5. Fuel Storage Area Sealed at  
Selfridge Air National Guard Base
